LAKE AGGRAVATION DAM
FRANKLIN COUNTY, MISSOURI
MO. 30557

PHASE 1 INSPECTION REPORT NATIONAL DAM SAFETY INSPECTION

LAKE AGGRAVATION DAM

**Phase I Inspection Report
National Dam Safety Program**

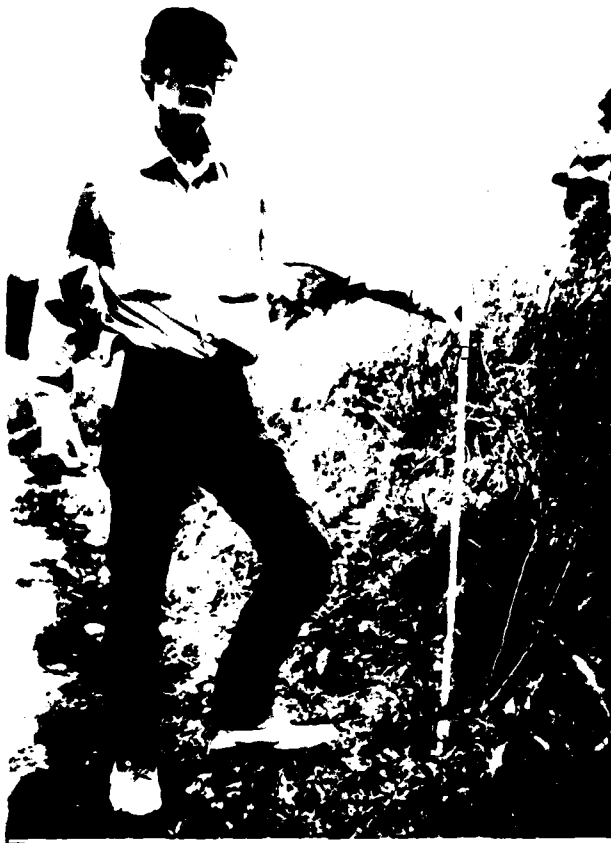
Evidence of minimal or no maintenance efforts on this facility include wave-cut erosion on the upstream bank of the dam, cracked and spalled concrete on the weir, trees growing in the discharge channel, and holes eroded through the discharge channel lining.

7. 2 ft wave-cut erosion on upstream edge of Lake Aggravation Dam; looking west.
